# Historical Evidence Review

**Observation area near Fischamend, Lower Austria****STATUS****WATCH**

**What changed within the observation area between 20 August 2023 and 19 August 2025, and which records would a bank need to assess the relevant construction milestone?**

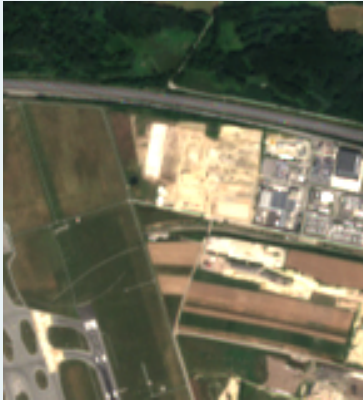
T0 - 20 AUGUST 2023

The dated imagery shows large roofed footprints at T1 where predominantly bare or construction-affected surface was visible at T0. This supports a bounded observation of visible change. Assessing a construction milestone requires the relevant project scope, dated documents and engineering evidence.

Which structures and project phase should the reviewer relate to these observations? Confirm the relevant asset boundary, milestone definition and dated technical records before assessing progress against a project plan.

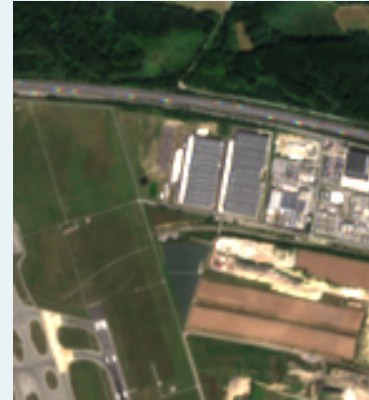
T1 - 19 AUGUST 2025

**Between 20 August 2023 and 19 August 2025, two large rectangular roofed structures became visible within the selected observation area, replacing predominantly bare or construction-affected surface.**

**Which dated project and engineering records define the relevant structures, milestone and acceptance criteria, and who is responsible for reviewing them?**
